# Stream Bioassessment Report

## Alachua County, Florida

### 2012-2014

Prepared for:  
The Florida Department of Transportation and  
Alachua County Environmental Protection Department  
**MARCH 2015**

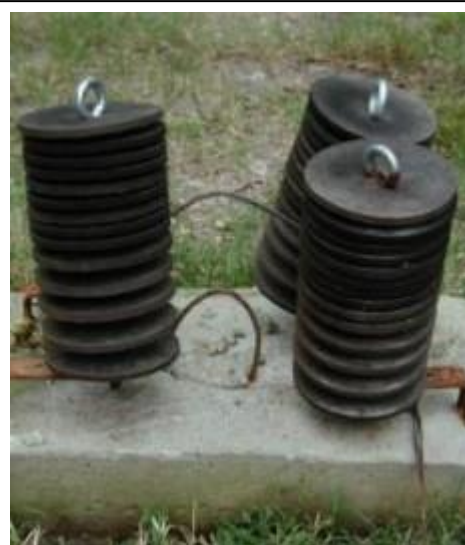
Hester-Dendy Sampler

Artificial substrates (Hester-Dendy samplers) are used to measure biodiversity by providing a quantitative method of analysis for Biological Integrity Criterion. Hester-Dendy samplers were deployed in Alachua County Creeks in 1996, 2000, and 2008-2009. The 2013 study was repeated at five locations. Three samplers were attached to a concrete block for each location. Guidelines found in DEP-SOP-001/01 FS 7430 (FDEP, 2008a; FDEP, 2014a) were used for all of the sampling events. The samplers were left in the creeks for 28 days. During this time, benthic macroinvertebrates climbed onto the samplers and lived between the plates, some forming cases, filtering food debris passing by, and scraping and eating periphyton and other algae and diatoms that may grow on the sampler. Predatory insects find this an opportunity to get a meal, as well. The following indices were used to evaluate the macroinvertebrate data collected.

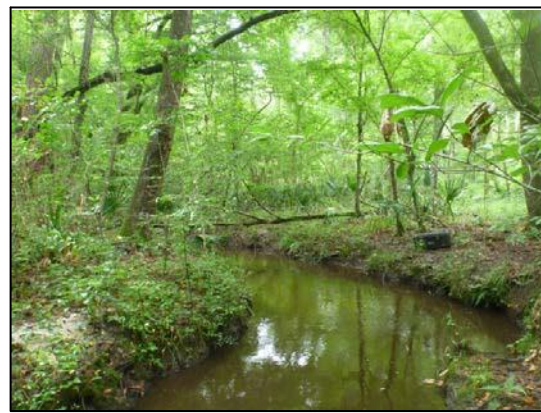
The stations with the highest SCI scores and achieving the rating of exceptional were Mill Creek at Old Bellamy Road (77 points), Hatchet Creek at Buck Bay (72 points) and Monterey Creek at NW 38<sup>th</sup> Drive (68 points). Previous BioRecons conducted on Mill Creek at Old Bellamy Road in 2002 and 2009 showed healthy results; however, higher numbers were observed in five of the six common metrics and an exceptional rating was achieved in the 2014 SCI assessment. Exceptional BioRecon results were observed in 2001 and 2009 at a station located downstream in Hatchet Creek at CR 225 in 2001

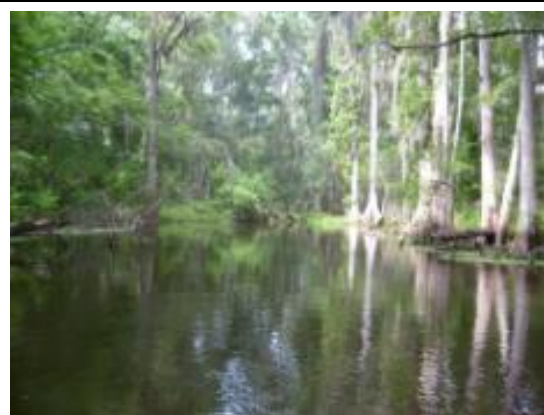
The only creek that attained the impaired interpretation was Prairie Creek south of SR 20 (19 points). This creek is actually a canal that carries water from Newnans Lake to Paynes Prairie and the River Styx, which flows to Lake Lochloosa. The SCI is not the best method for evaluating canals and the FDEP is in the process of developing an SCI assessment which is modified for canal evaluation. The condition of the macroinvertebrate community in Prairie Creek is likely attributed to the water quality in Newnans Lake, known to be high in nutrients and turbid. The particulates in turbid water can clog the feeding mechanisms of filter feeding invertebrates. Prairie Creek had the lowest percentage of filter feeders in the study and no sensitive organisms were found. Because of the low SCI score and the abundance of the amphipod *Hyalella azteca* complex (average 54.28%), this site was re-sampled using the BioRecon method in 2014. The BioRecon score is not influenced by a single abundant organism. The BioRecon results showed a higher number of taxa (28 compared to 23 in the SCI), higher number of Trichoptera taxa (3 compared to 1) and more long-lived taxa (3 compared to 1). However, no sensitive taxa were found and the resulting score was still classified as impaired. In spite of the Prairie Creek macroinvertebrate community, the riparian zone is beautiful with habitat assessment scores in the suboptimal range (113 – 118 points).

Prairie Creek south of SR20  
Paynes Prairie Preserve State Park

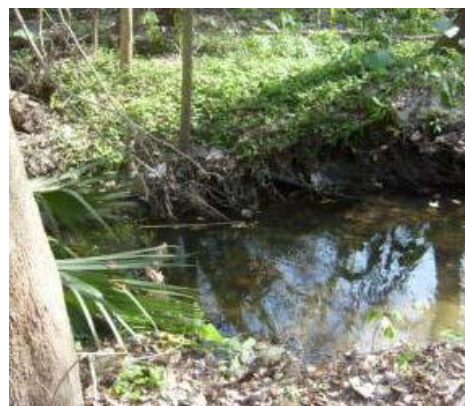
Tumblin Creek Deployment Site

The creeks assessed with artificial substrate/Hester-Dendy samplers were concentrated in the Gainesville urban area within the Orange Creek Basin. The sample locations include Springstead Creek at US 441, Hogtown Creek at Haile Sink, Tumblin Creek in the wooded area, and the North Branch of Little Hatchet Creek. Hatchet Creek was sampled at the sink on Alachua County Forever land (Newnans Lake Conservation Area - Hatchet Creek Addition) where the creek partially flows underground (and under low water conditions the sink may capture all of the flow). The Hester-Dendy samplers were collected in good condition at all locations. However, at Tumblin Creek they were partially sand-smothered but still well-populated. The samplers were redeployed at Hogtown Creek due to removal by the landowner. Before redeployment, the owner was advised of their purpose. The samples were collected and processed by Water & Air Research, Inc. The results are also presented separately in the *Quantitative Bioassessment Report of Five Alachua County Creeks: Hester-Dendy Sampling and Analysis 2013*, Water & Air Research, Inc. (Appendix D).

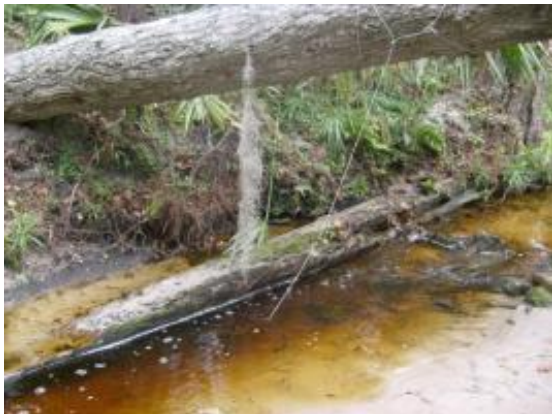
Springstead Creek west of US 441  
Hester-Dendy samplers placed in a sheltered  
area near the bank

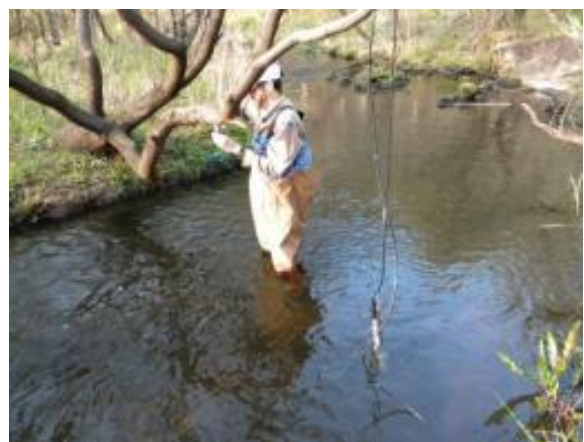
Hester-Dendy sampler deployment  
Hogtown Creek at Haile Sink

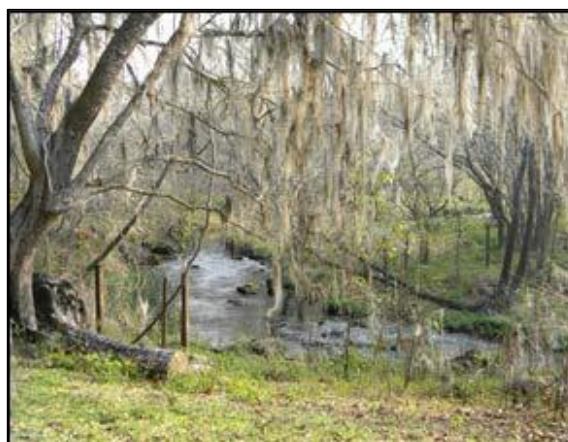
Hogtown Creek at Haile Sink

The water quality in Hogtown Creek at Haile Sink appeared to be in good condition; however, the increased abundance of periphyton on the rocks and other habitats indicates nutrient enrichment. The habitat assessment scores were very high and that raises the expectation of a higher score for the SCI evaluation. Hogtown Creek can be enjoyed near the Haile Sink at the City of Gainesville's Split Rock Conservation Area.

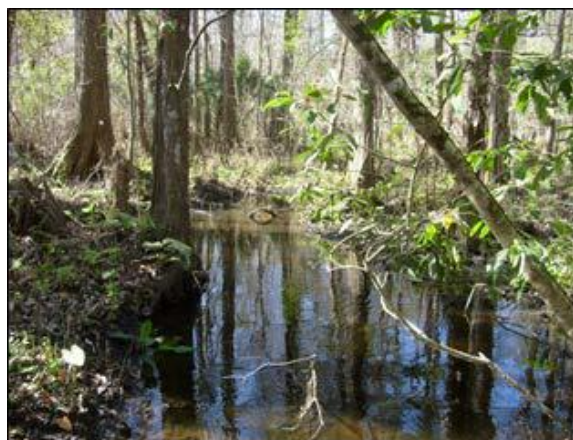
Lake Forest Creek, south of CR 329B

Lake Forest Creek was an average of 2 meters wide and 0.15 meter deep. No erosion of the banks was observed and no pollution sources were evident. The water velocity was fair, averaging 0.13 meters per second. The water was colorless and slightly turbid. The sediment was sand and silt with an anaerobic odor. A sheen, possibly caused by decaying natural organic material or iron bacteria, was observed on the water surface. Temperature, pH, and dissolved oxygen were within healthy ranges.

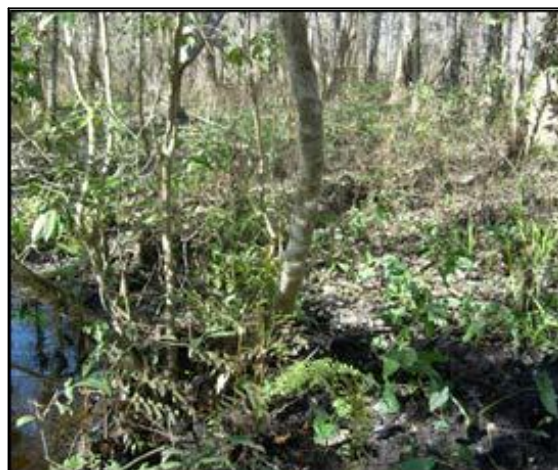
Mix of Native and Exotic Vegetation

The riparian zone was greater than 18 meters wide with mainly native wetland plants; however, exotic Taro was growing near the road. The creek was moderately shaded, and periphyton, fish, and aquatic macrophytes were common. The habitat suitable for benthic macroinvertebrates included roots of vegetation living on the banks, leaf packs, snags of fallen tree branches, and aquatic plants. The habitat was noted to be severely silt-smothered, but there were some pools and riffles. Of 160 possible points for the habitat assessment, Lake Forest Creek received 130 points placing it in the optimal range.

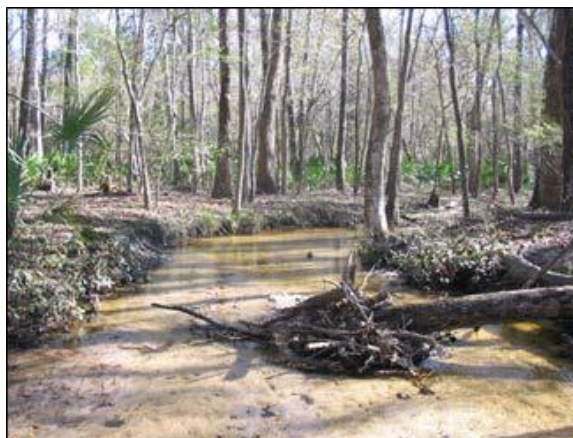
Little Hatchet Creek, Airport Industrial Park

The headwaters of the North Branch of Little Hatchet Creek are located near the Gainesville Regional Utilities Murphree well field, and Ironwood Golf Course in northeastern Gainesville, Alachua County, Florida. The creek flows from west of SR 24 (NE Waldo Road) to the east through the Gainesville Airport Industrial Park and south through Gum Root Swamp to Newnans Lake. Upstream of the sampling sites, the watershed contains a variety of land uses: 12% pine plantation, 46% natural forest, 12% residential neighborhoods, 21% industrial, and 9% commercial. Little Hatchet Creek receives reclaimed water (treated wastewater effluent) from the domestic wastewater treatment facility at Brittany Estates Mobile Home Park, which is upstream of the sample sites.

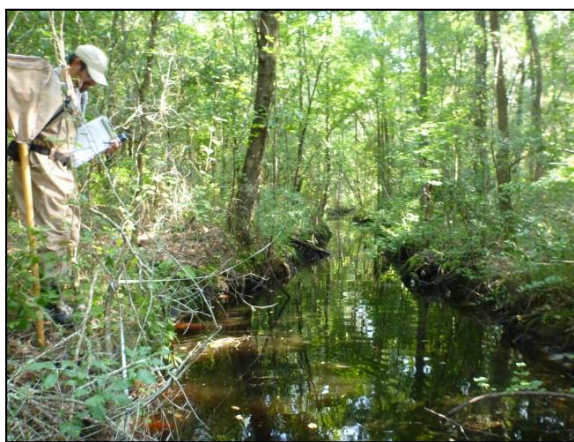
Little Lochloosa Creek

Little Lochloosa Creek averaged 2.5 meters in width and the average depth was 0.3 meters. Non-point source pollution was not evident at the site. The water velocity was 0.11 m/s at a narrow, shallow section of the stream, but generally there was little flow. The water was clear and tea-colored (tannic). No unnatural odors were present; however, an oily sheen from decomposing leaves was observed. Temperature and pH were within normal ranges. The low dissolved oxygen was likely due to the low flow and dark tannic water typical of a wetland stream. Low specific conductivity was likely due to recent rainfall and lack of a groundwater source contributing to the creek.

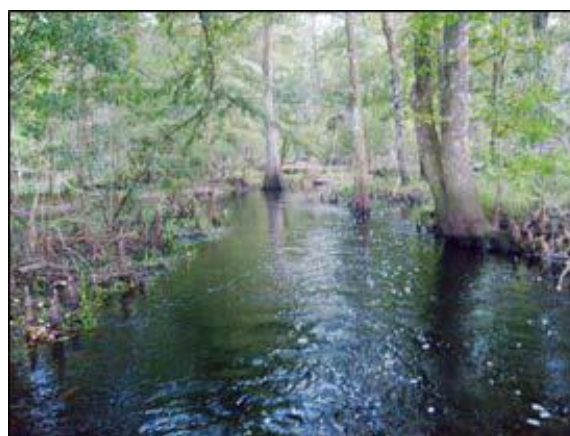
Lochloosa Creek

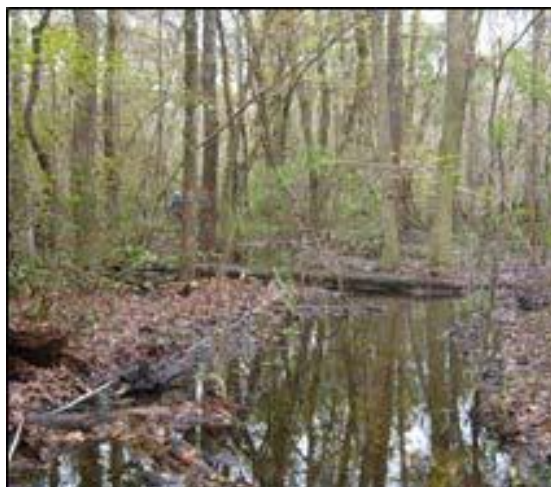
Possum Creek at NW 53<sup>rd</sup> Avenue

Possum Creek at NW 53<sup>rd</sup> Avenue was an average of 1.8 meters wide and 0.15 meters deep. The banks were low with no erosion noted. Non-point source pollution was possible from NW 53<sup>rd</sup> Avenue, a nearby shopping center, and an electricity transfer station. The water velocity was fair at 0.17 m/s. The water was stained lightly tannic (tea-colored), no unnatural odors were present, but sheen was noted on the surface in pooled areas possibly from decomposing vegetation. Temperature, pH, and dissolved oxygen were all within normal ranges.

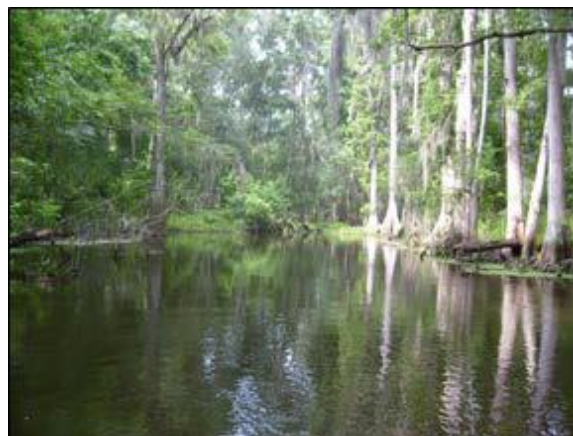
Prairie Creek south of SR 26  
Paynes Prairie Preserve State Park

The habitat assessment score was 113 in 2013 and 118 in 2014, which was in the suboptimal range, showing marginal scores in substrate availability and artificial channelization in 2013. However, the reach did not appear to have been channelized, but had sinuosity with pools and shallow areas. In 2014, the only habitat greater than 2 square meters in size was snag habitat (submerged tree branch). Small amounts of aquatic vegetation and leaf packs were also observed.

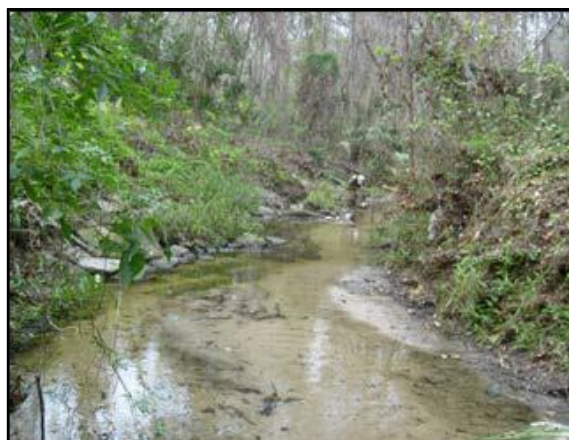
Springstead Creek at US 441

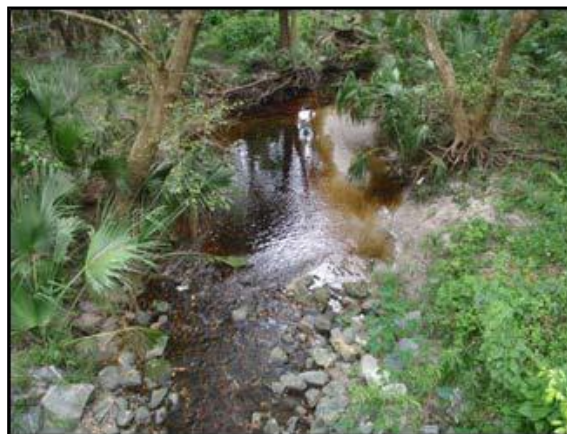
Sweetwater Branch at SE 4<sup>th</sup> Avenue

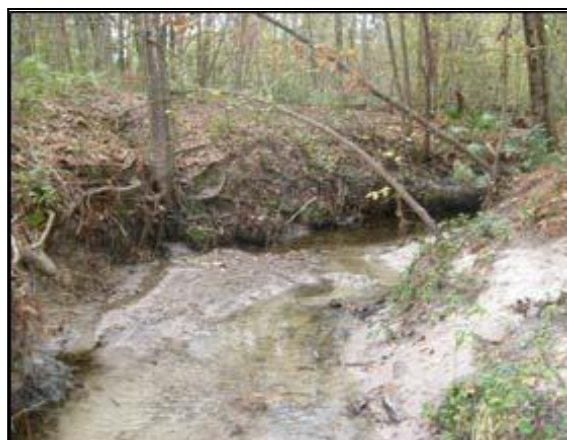
Three Lakes Creek upstream of Glen Springs Road

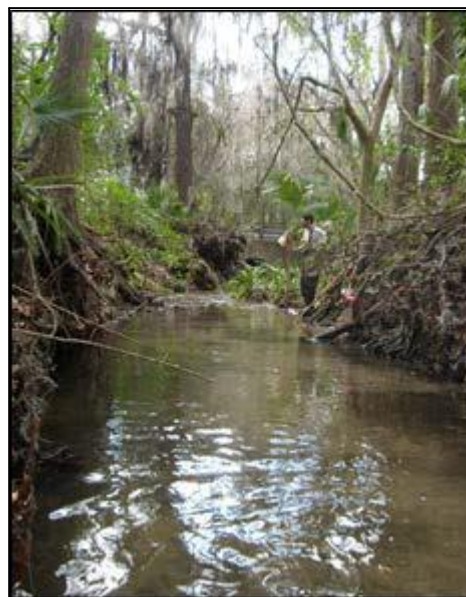
Tumblin Creek at SW 14<sup>th</sup> Avenue

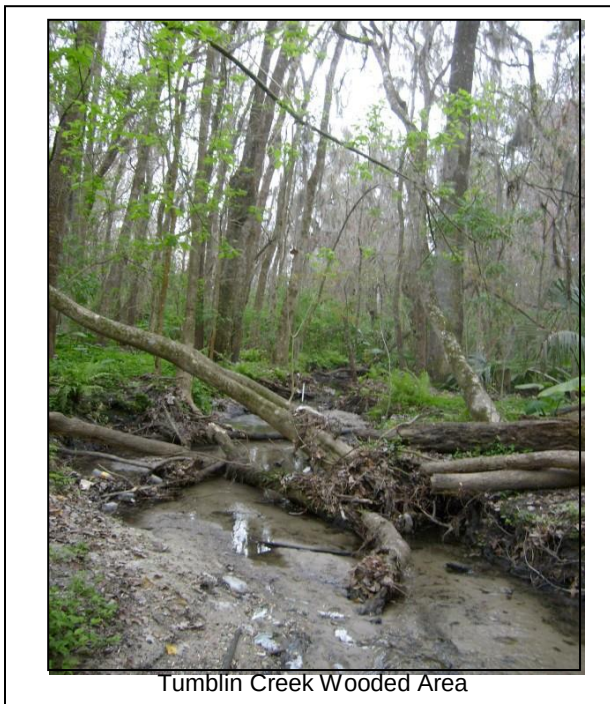
Tumblin Creek Wooded Area

Tumblin Creek was about two meters wide, but braided (overloaded with sediment and broken into smaller channels) and about 0.1 meter deep. Non-point source pollution was obvious upstream of the site from roads, parking lots, residential, commercial, and industrial areas. The water velocity at the time of the 2013 sampling event was 0.17 m/s; the water was clear and colorless, with no unnatural odors or oils there or in the sediment. Dissolved oxygen, temperature, specific conductivity, and pH were within normal ranges considering the time of the year the sampling was performed.

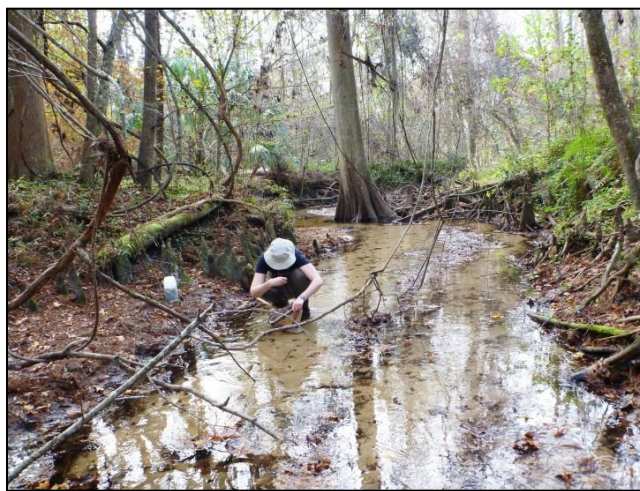
Turkey Creek near NW 71<sup>st</sup> Way

The habitat suitable for macro-invertebrates observed at NW 71<sup>st</sup> Way included snags of fallen tree branches and leaf packs. Roots of vegetation living on the banks were mostly out of the water or cypress tree roots offering minimal root habitat. The bottom was mostly sand with fallen leaves and there was a small amount of riffle made of small pebbles. The riparian zone at the site began as shady lawn, but most of the 100-meter reach was lightly shaded with native trees, mostly cypress, and some ground cover of exotic plants. Sparse amounts of blue-green algae could be seen on the sand in sunny areas. Fish and macrophytes were rare. At this site the creek did not appear to have been channelized in the past, but if it had, it appeared to have recovered.

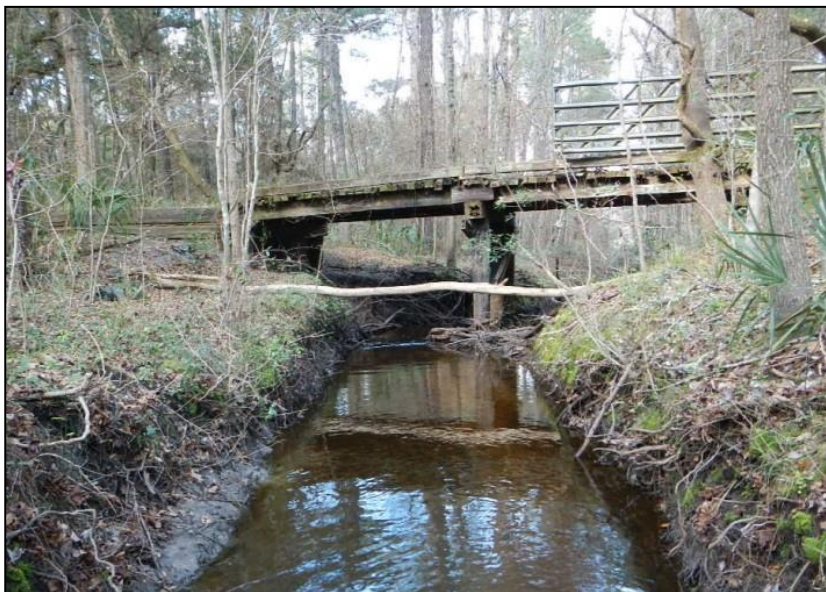
Turkey Creek appears to have improved since it was first sampled in 2003. However, the sampling site was relocated in 2014, and was recently sampled in two areas which have a more natural riparian buffer zone. Sand smothering has been reduced, the velocity of the current has increased (perhaps due to increased rainfall over the past year), and the biological community reflects that change. The creek flows through the residential Turkey Creek subdivision and the natural forested area in Turkey Creek Hammock Preserve (recently acquired by the Alachua County Forever program) before it enters San Felasco Hammock State Preserve and flows through the park, finally dropping into swallows, which drain back into the aquifer. Efforts to preserve and restore land along the waterway and to limit stormwater runoff have helped to make the biological community healthier and more diverse in Turkey Creek.

Turkey Creek in ACF's Turkey Creek Hammock Preserve

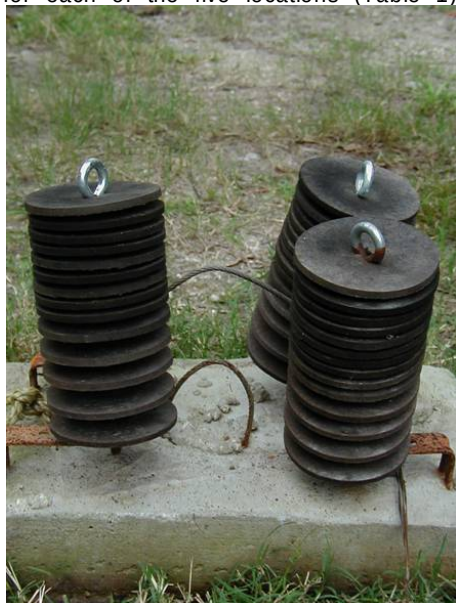
**Hester-Dendy Sampler Set-up**

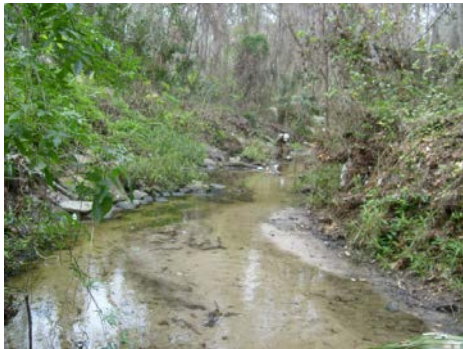
Location: Hog 16

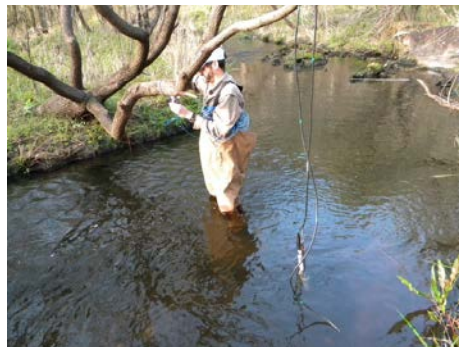
**The Hester-Dendy sampler is in the water, being tied off to a tree as the multi-parameter probe takes readings at Hogtown Creek upstream of the Haile Sink location.**

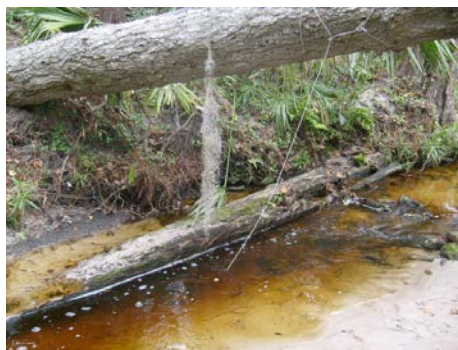
**Springstead Creek Hester-Dendy samplers were located in a sheltered area near the bank.**

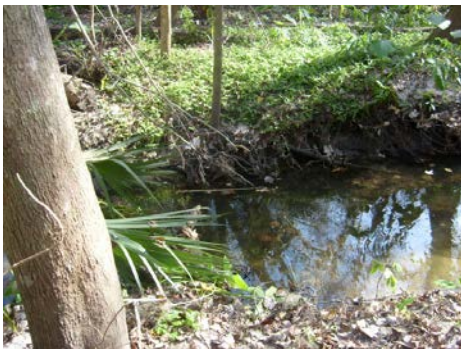
The Tumblin Creek Hester-Dendy Sampler is located in this pool.
